Atlas 7B shaper

Cross feed gear housing – casting S7-25D – repair

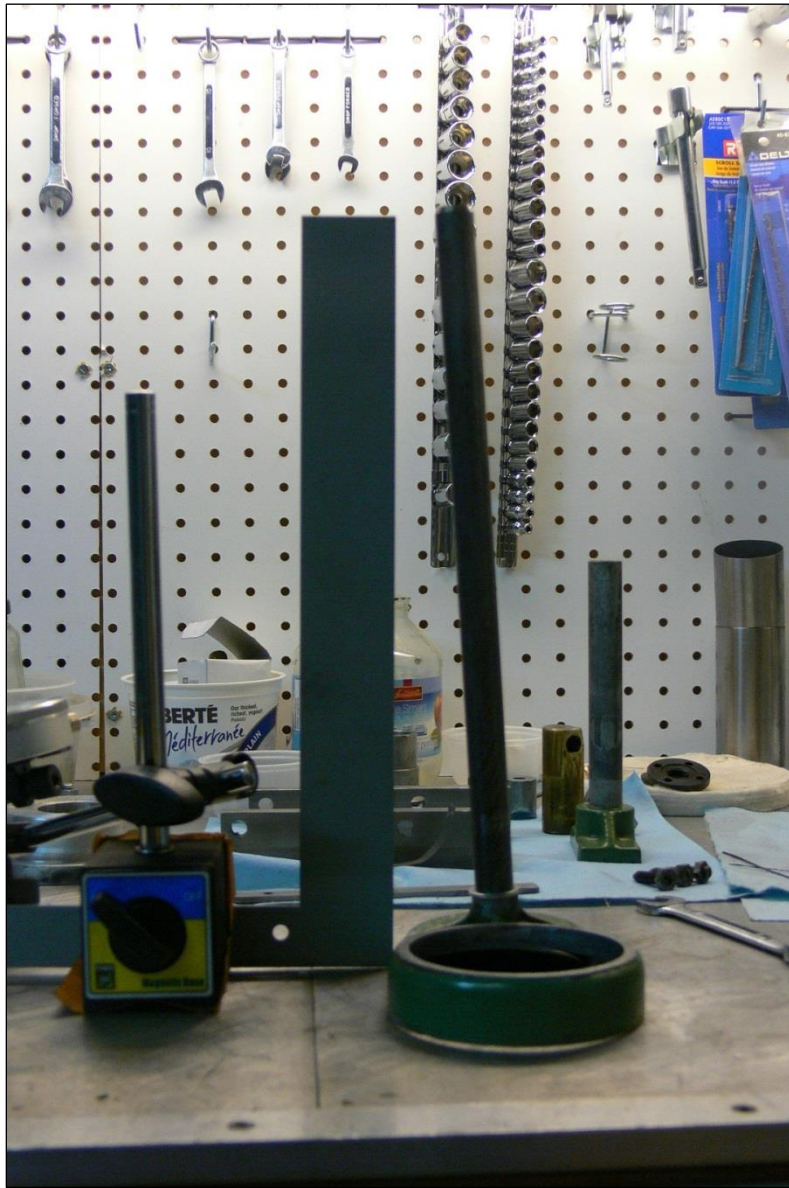
The cross feed gear housing (S7-25D) on the shaper was severely distorted, causing gears S7-86 and S7-68A meshing improperly. Casting is made out of ZAMAK, zinc-aluminum alloy that has tendency to cold flow / creep under the stress. Not sure if this was the case here as there are no real forces imposed on this part when shaper is operating or stationary. It could have been an impact damage as well, who knows.

Figure 1 -Before repair

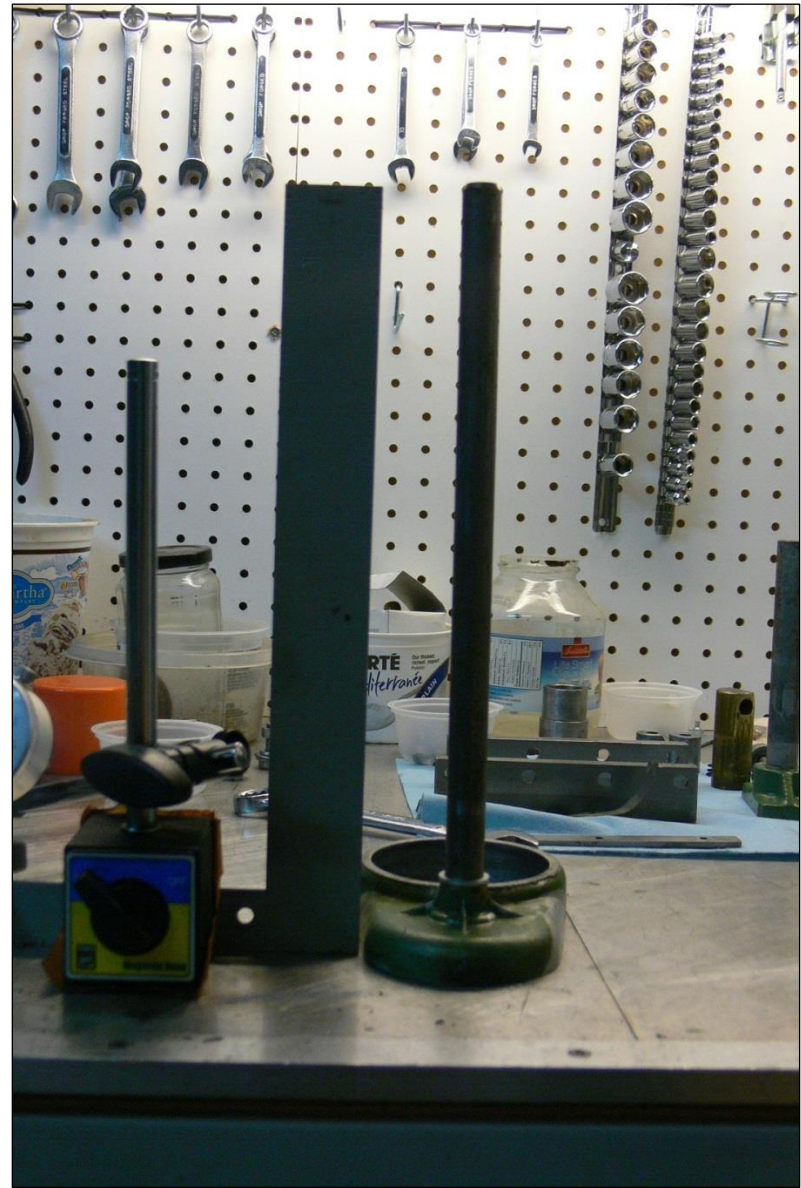
Figure 2 - After repair

5/8" cold rolled bar. The casting was clamped on to the plug and then held in the vise. Area of casting with distortion was then heated with the heat gun to about 200°C (the alloy has melting point of about 380°C). Gentle pressure was gradually applied to the straightening lever and straightness was checked with a square, until the casting was straight.

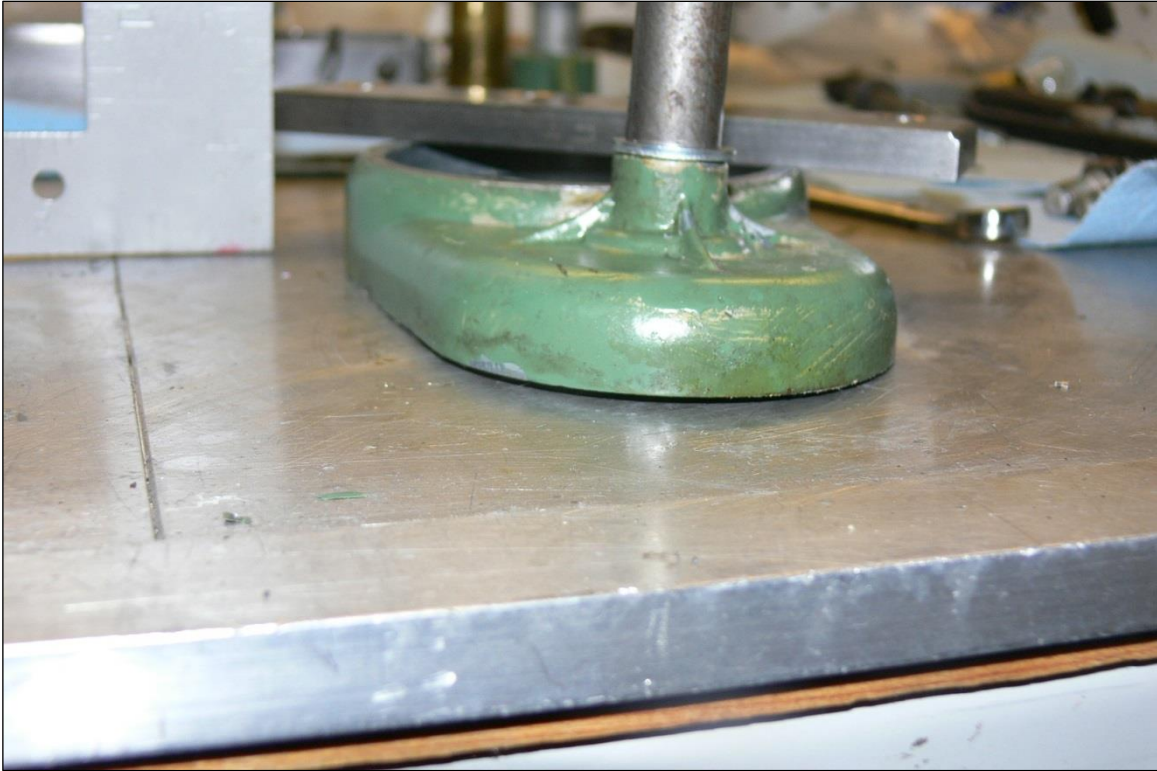
Figure 3 - Casting distorted before repair

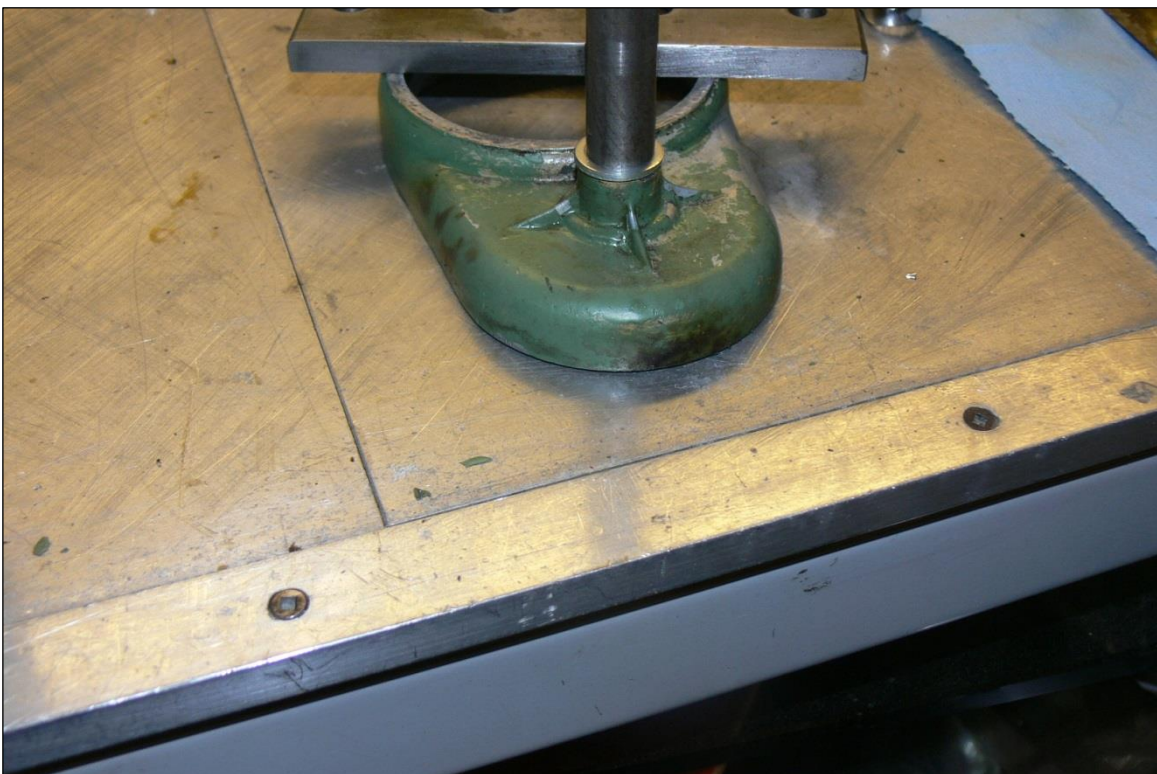
Figure 4 - Casting straight (more-less) after repair

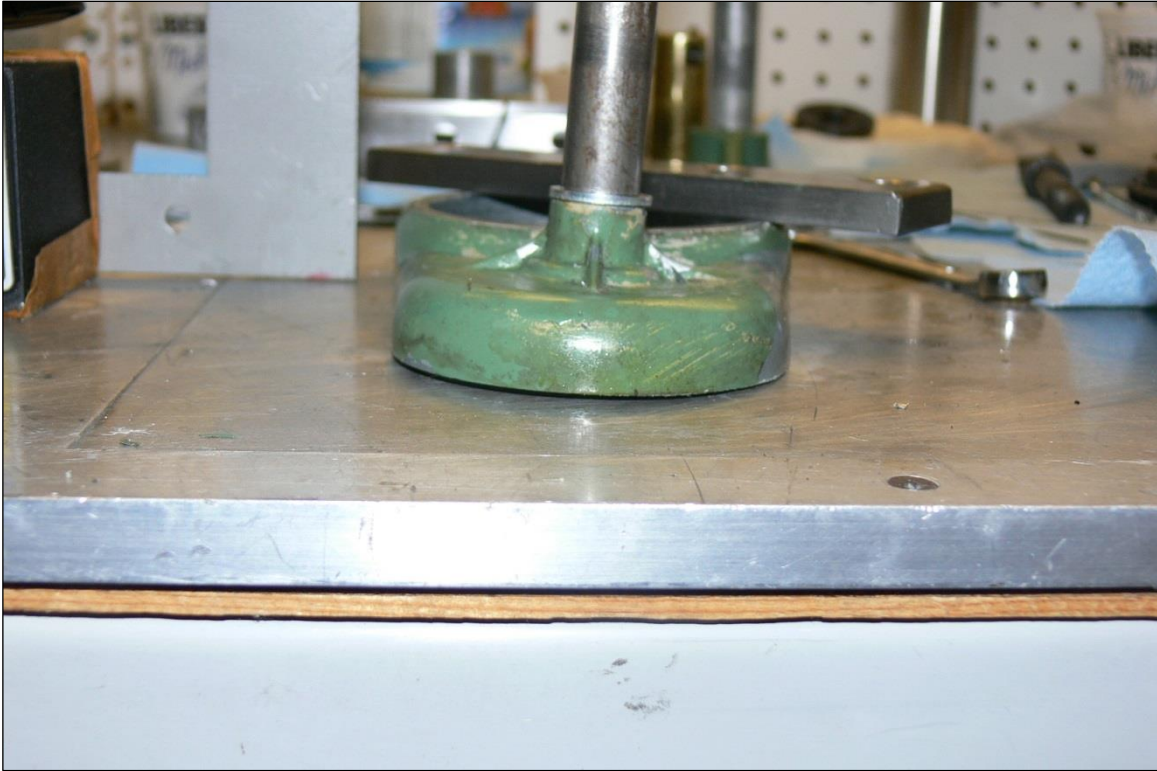
Figure 5 - Casting distorted before repair

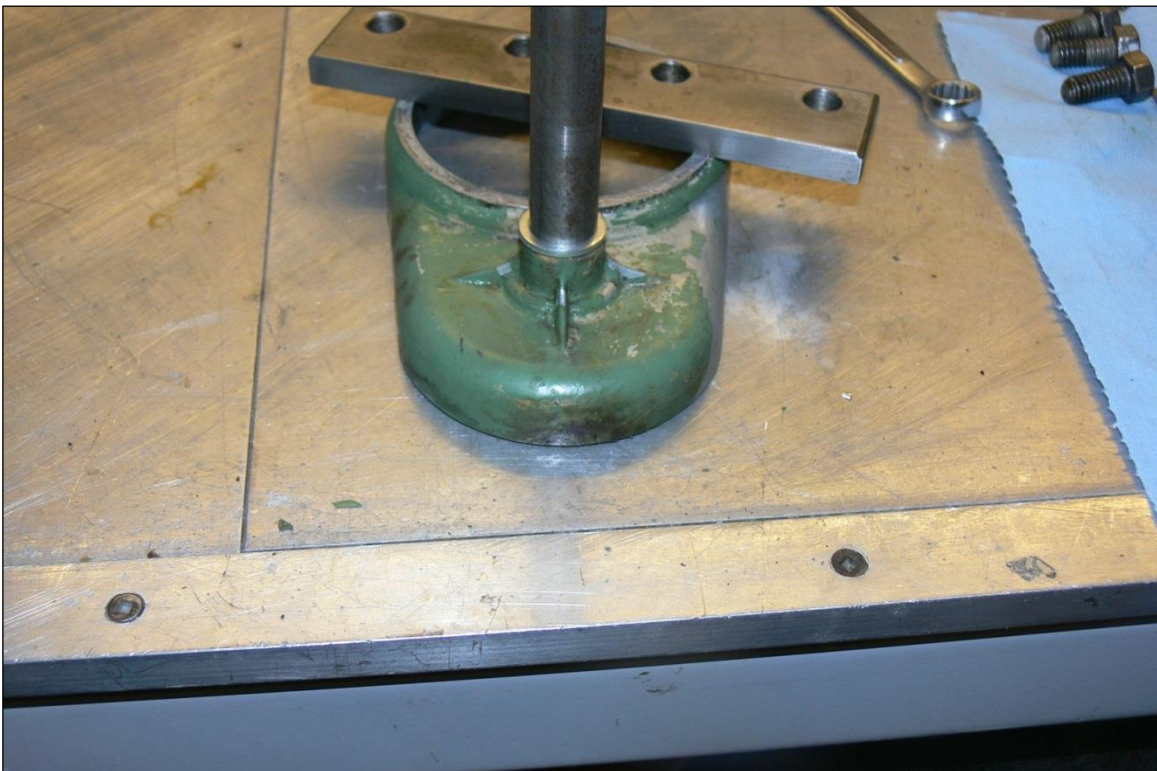
Figure 6 - Casting straight after repair

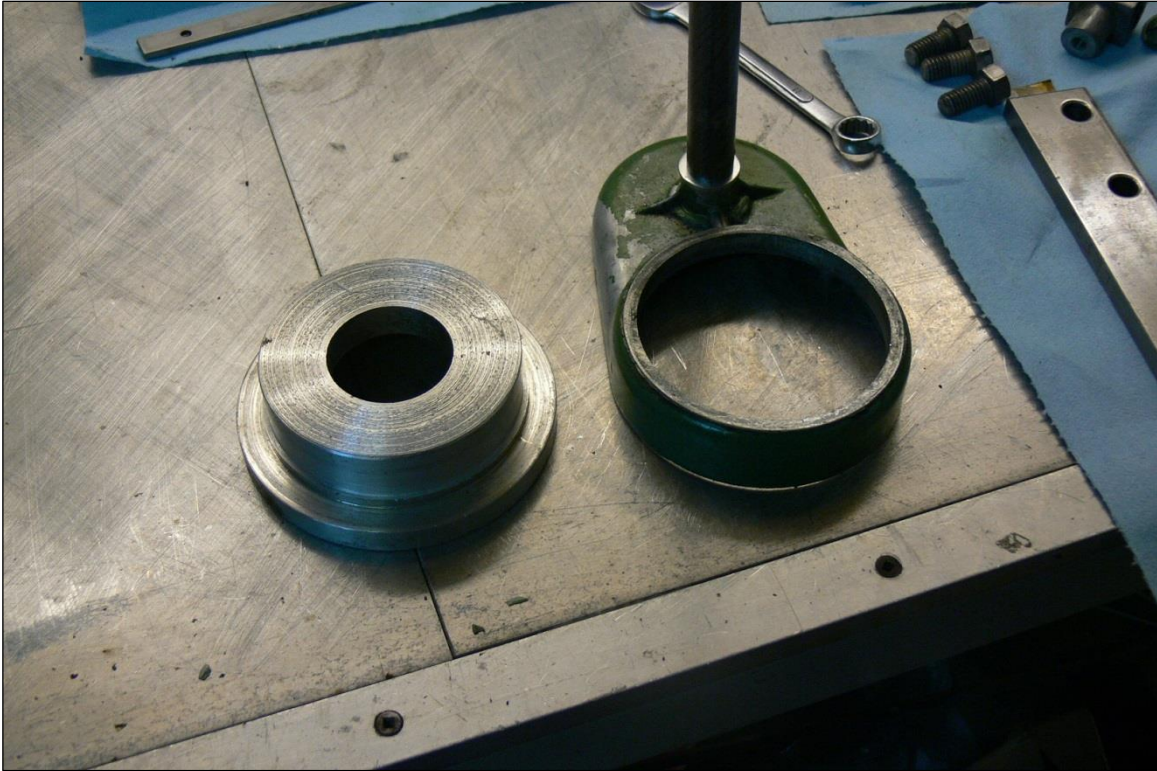
Figure 7 - Aluminum plug to hold casting in the vise

Holding plug was machined from the old aluminum piston (from a hydraulic cylinder) and straightening lever from

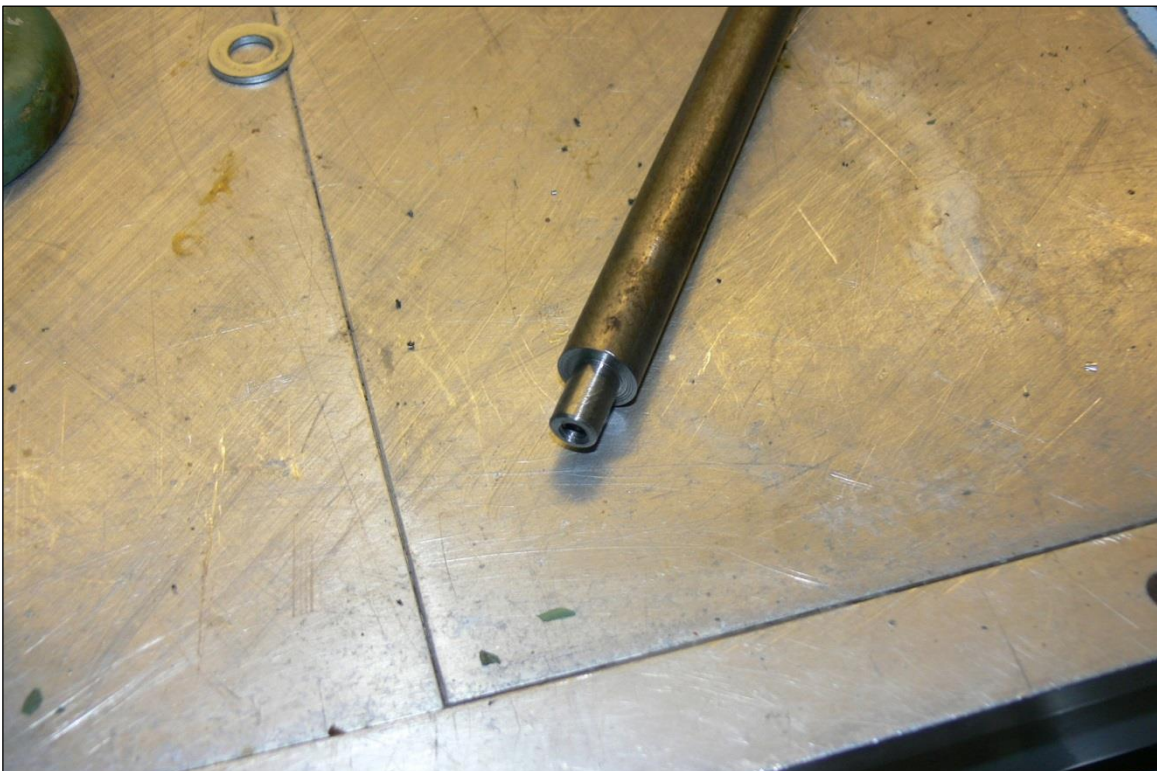
Figure 8 - Steel lever for straightening

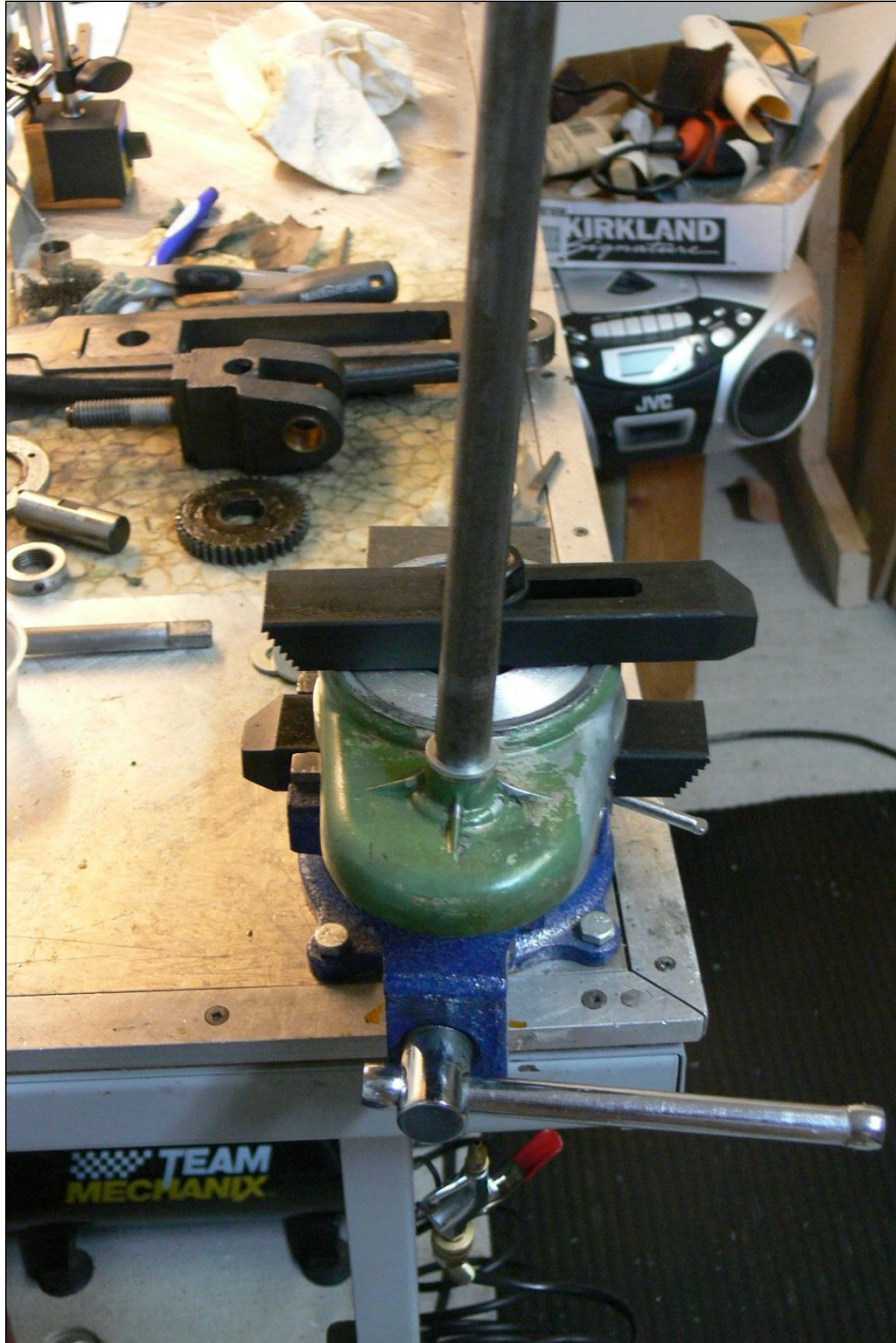
Figure 9 - setup in the vise, ready for heating and straightening
